PIPELINE INVESTIGATION REPORT

P00H0061

NATURAL GAS COMPRESSOR STATION OCCURRENCE

GAZODUC TQM INC.
EAST HEREFORD COMPRESSOR STATION
KILOMETRE POST 217,094 ON LINE 3000
APPROXIMATELY 80 km SE OF MAGOG, QUEBEC
EAST HEREFORD, QUEBEC
28 DECEMBER 2000

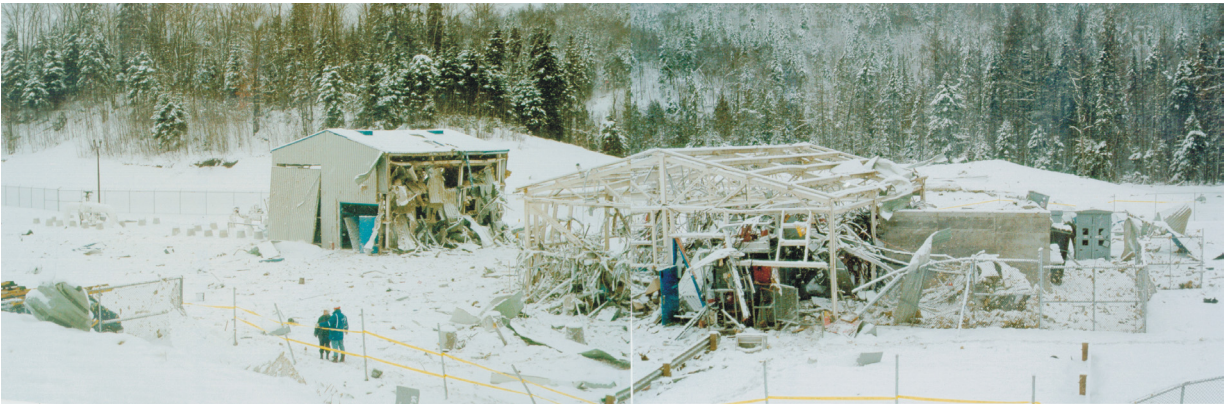
Photo 1. Panoramic view of East Hereford compressor station (after explosion)

Damage to TQM's East Hereford station was extensive. The main components were completely destroyed or damaged as follows:

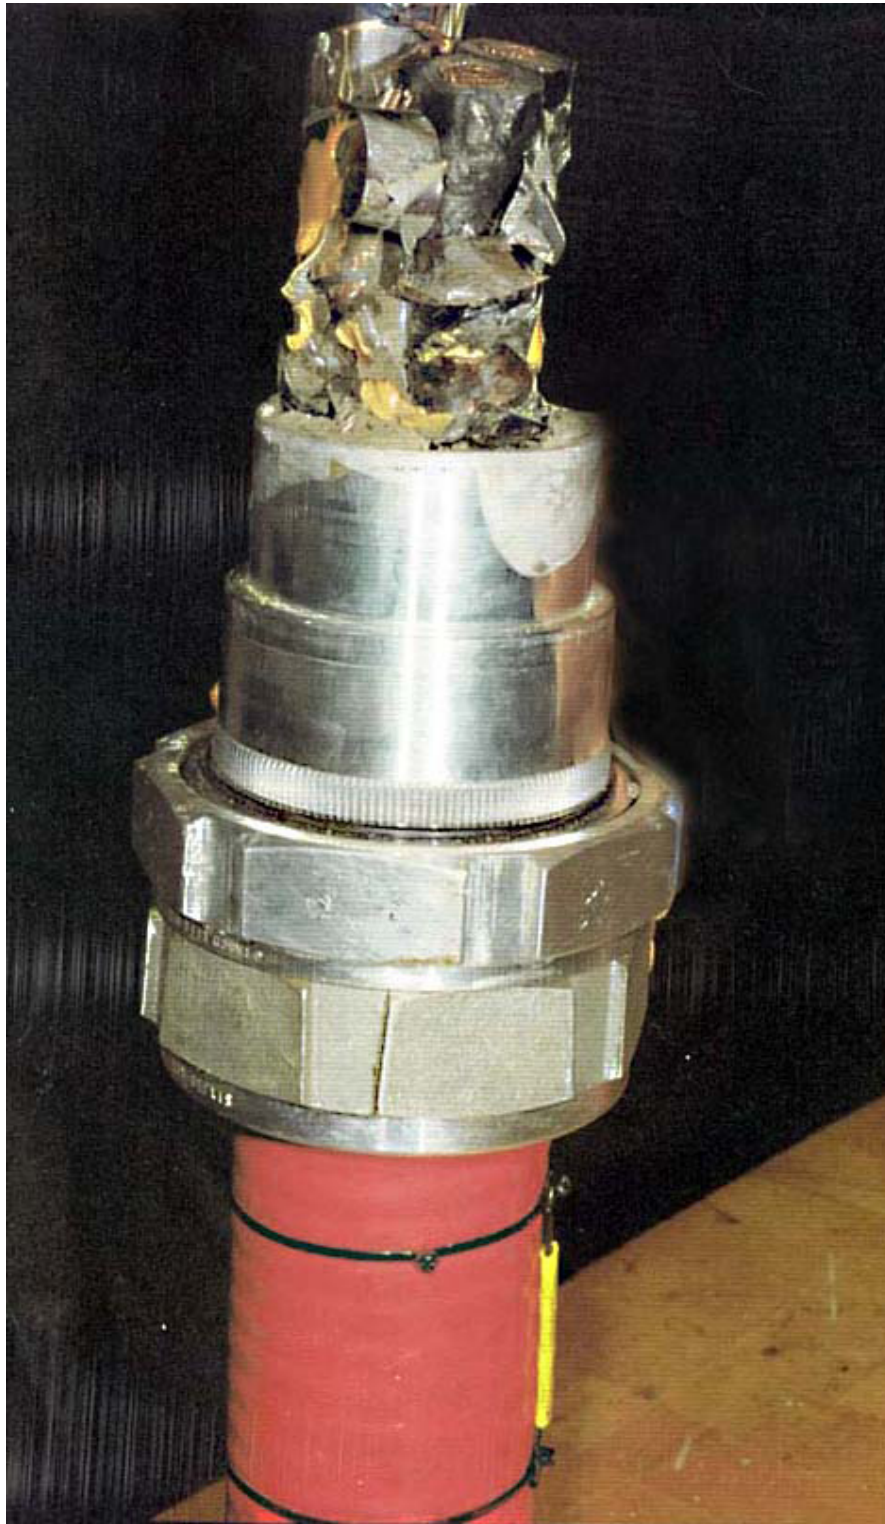
*Appendix E— Bottom Plate Fitting for the Terminal Junction
Box (Scale: 1 to 2)*

An integral part of the MOPICO motor/compressor unit is the Passthru flange, a high-pressure sealing flange between the motor and the TJB. The fitting shown in Appendix E does not form part of the MOPICO, but is the physical means for power delivery from the ESB. The Passthru flange mechanically seals and permits electrical connections from the TJB, which operates at atmospheric pressure, to the electric motor, which operates at the midway pressure between compressor suction and discharge pressure. It is built of stainless steel and features 12 specially designed Passthru penetrations, through which an electrical conductor passes. Referred to as a "Passthru element," each electrical conductor consists of two O-rings made of a synthetic, flexible compound called Viton-Type "A" (Viton), a copper rod, a long brass outer ring, and an epoxy filler. Each Passthru element is used to conduct electric power to the motor from the connection points inside the TJB. Each Passthru element is designed to fit into one of the Passthru flange penetrations to form a tight, mechanical seal that is further protected from any gas leaks by the two Viton O-rings.

The fitting design was approved by both the CSA and UL for use in Class I, Division 2, Group D hazardous areas. This design provides a number of special features for connecting and disconnecting the Teck cables from the TJB during maintenance and general servicing. First, the fittings safely anchor the two Teck cables to the bottom of the TJB. Once secured to the TJB, the Teck cables can be easily disconnected for maintenance and reconnected without a major reinstallation process. Second, the fittings also furnish a seal where the cables enter the TJB. While these fittings were not designed to be gas tight, the seal at the ends of Teck cables was designed to inhibit or prevent an explosion inside the TJB from migrating through the Teck cables, thus preventing an extension of a dangerous situation into the ESB. The fitting was designed to diffuse hot gases in a controlled manner, which lowers the temperature, thereby preventing explosions inside an enclosure from propagating to atmosphere outside the enclosure. However, the fitting was not designed for continuous pressure service, as was the case with the TJB. Since there was no effective means of preventing any buildup of hot or cold gas from migrating out of the TJB along the two Teck cables, the pressure transmitter would not function as intended.

During a laboratory test, the TJB was inspected to identify any surface and structural damage that could indicate a potential escape route for natural gas. There was no surface or structural damage noted on the TJB, the door and the associated flanged connections located at the back of the box. The two fitting/Teck cable assemblies from the bottom of the TJB and the associated pieces of Teck cables were visually inspected and then each was physically dismantled by machine sawing through each assembly lengthwise. One of the two fitting/Teck cable assemblies did not have the recommended sealing compound and it had been improperly installed. The inner jacket of the cable was not skinned off to expose the conductors in the sealing chamber of the fitting as stated in the supplier's instructions, and a felt barrier had not been placed in the assembly. A chemical analysis determined the material to be "Chico," a commonly available material used in the electrical industry in Canada. While there had been an attempt to install a felt barrier, the second fitting/Teck cable assembly had no sealing compound. A felt barrier is installed before any sealing material to hold the material in place until it solidifies. In both cases, the entry points into the bottom of the TJB were covered by another sealing compound, which is normally used to protect against the progression of a flame and is referred to as "flame guard." An inspection performed during laboratory testing determined that it had been poorly installed and did not provide any sealing capability.

2. The failure to properly install sealing compounds and the failure to skin off the inner jacket of the cables to expose the conductors inside the sealing chamber in two electrical fittings affixed to the electrical TJB for the compressor unit provided an open channel for the free flow of natural gas through two electrical Teck cables between the explosion proof-rated compressor building and the non-explosion proof-rated electrical and services building (ESB); that was not in conformity with the requirements of *Canadian Electrical Code* (CEC) 22.1.
